Minerals Inspection Report

Report Date: 07/14/201	4		
Mine Name: Bromide Basin		Permit Number:	S/017/0031	Mine Status:	Active
Ope	rator Name: Bromide Mining LLC.	Inspection Date:	07/09/2014	Permit Fees:	Paid
Inspector(s): Wayne Western		Inspection Time:	9:30 - 10:30 am	Bond Amount:	\$57,600
Attendee(s): John Reay		Weather:	warm and sunny	Bond Escalation:	07/22/2017
Insp	ection Purpose: Routine inspection			Prior Inspection:	05/21/2014
Pern	bond is current nittee must get an agreement with the BLM and nittee must divert water so that it flows in the nat			work.	
	Elements of Inspection			raluated & Commented	Enforcement

Mine: S/017/0031 Inspected: 07/09/2014

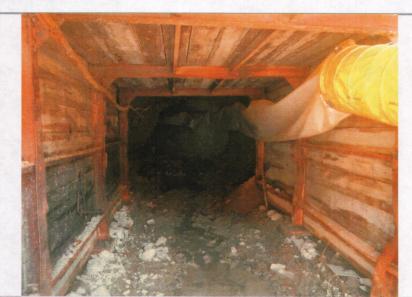
Water flowing out of the adit. Looking inward.

3.	Protection of Drainages/Erosion Control				
3.	The Operator needs to direct water coming out ditch.	of the adit into a culvert befor	e it crosses the road		er flow into a

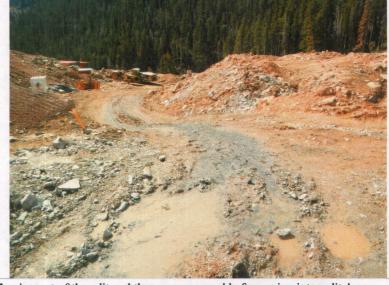
Water flowing out of the adit and then across a road before going into a ditch.

4.	Deleterious Material				
5.	Roads (maintenance, surfacing, dust control, sa	afety)			
	The Operator needs to constantly keep the road overnight. Water should be diverted into culve		The Division unde	erstands that new spring	s can appear

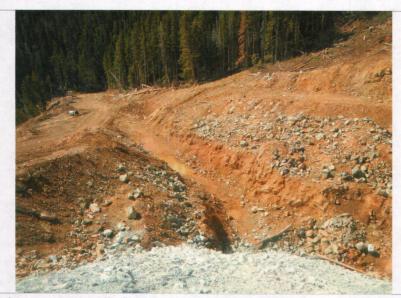
Ditch where water eventually flows into.

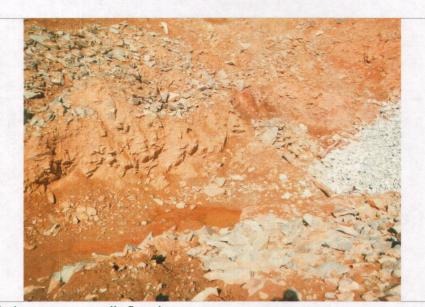
Pond where water eventually flows into.
